GREAT NEAPOLITAN EARTHQUAKE OF 1857.

OBSERVATIONAL SEISMOLOGY

TO INVESTIGATE THE CIRCUMSTANCES OF THE GREAT
EARTHQUAKE OF DECEMBER 1857.

ROBERT MALLET, C.E., F.R.S., F.G.S., M.R.I.A.,
&c., &c.

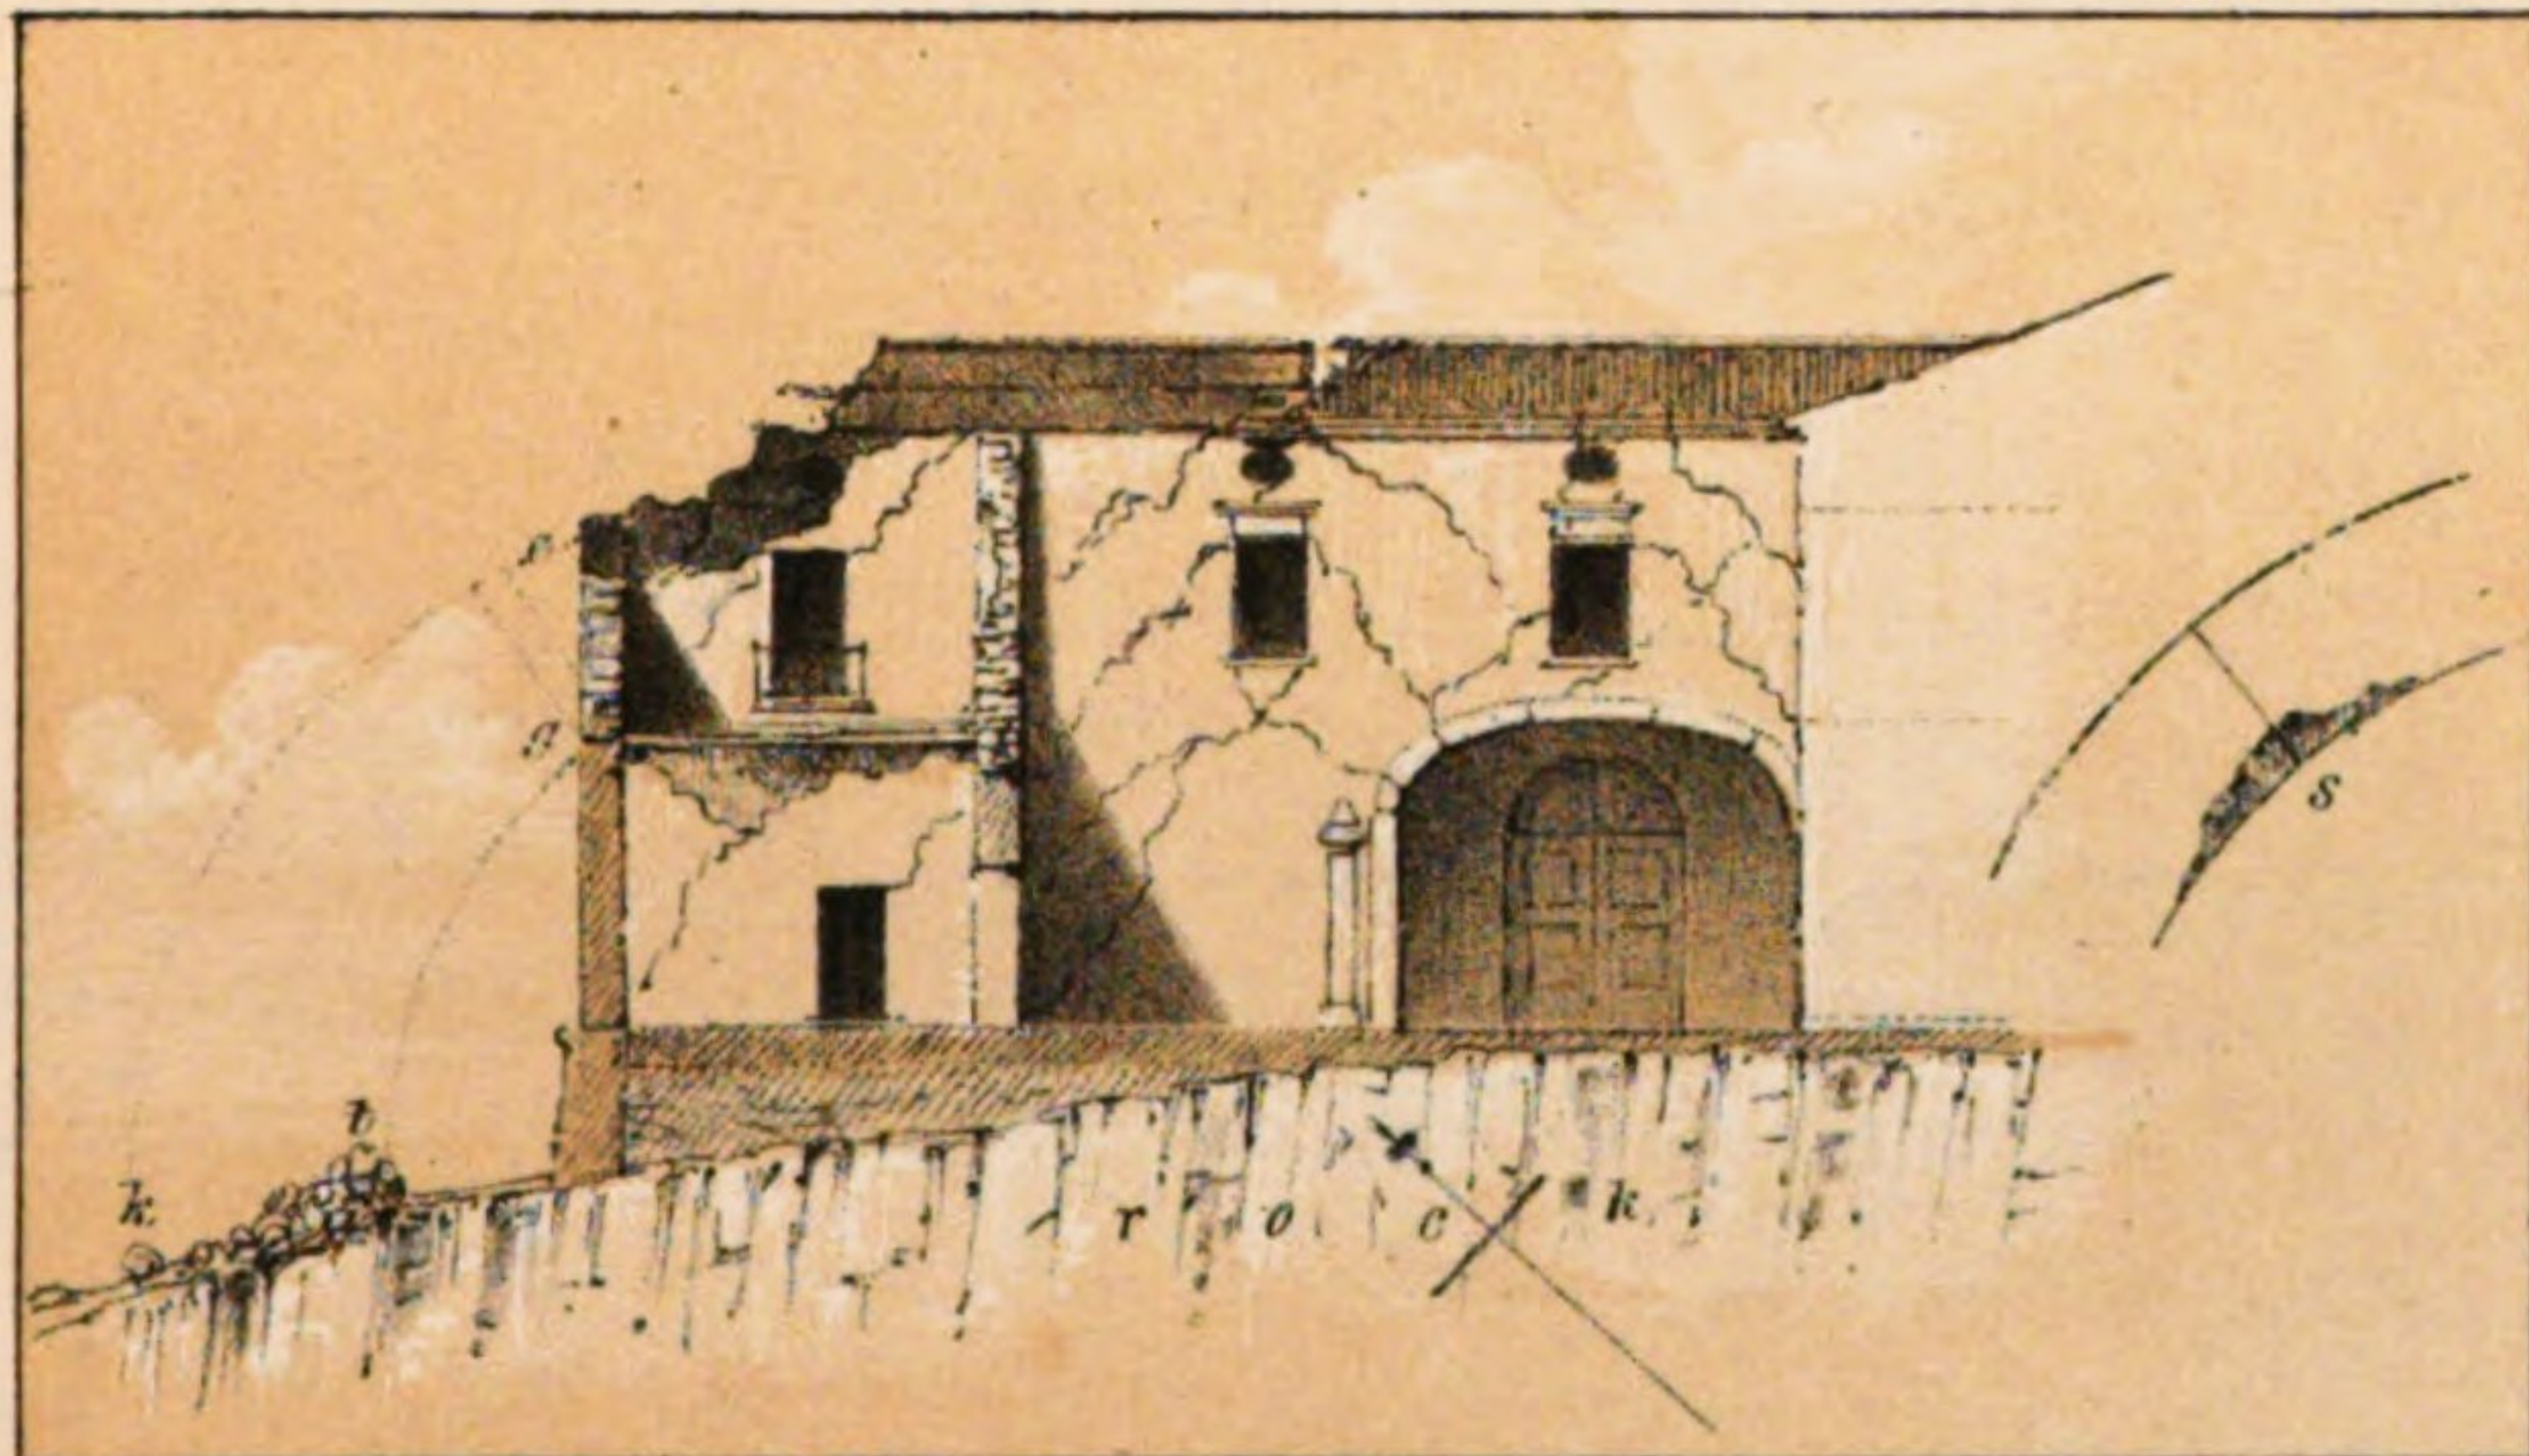
Sketch. Pl. 156.

This is sketched in Fig. 156. It appears as if produced by the falling in of the roof, of a cavernous enlargement of the subterraneous duct at this point; and the mass standing up in the middle of the crater-like cavity, is probably part of the roof, tilted over in the fall, and sustained by other fragments beneath. The Padre said there was no water at the bottom, nor any entrance from it to a subterranean chamber, and it had received no alteration, that he was aware of, since the earthquake. The cavity is probably a quarter of a mile long, from right to left in the sketch.

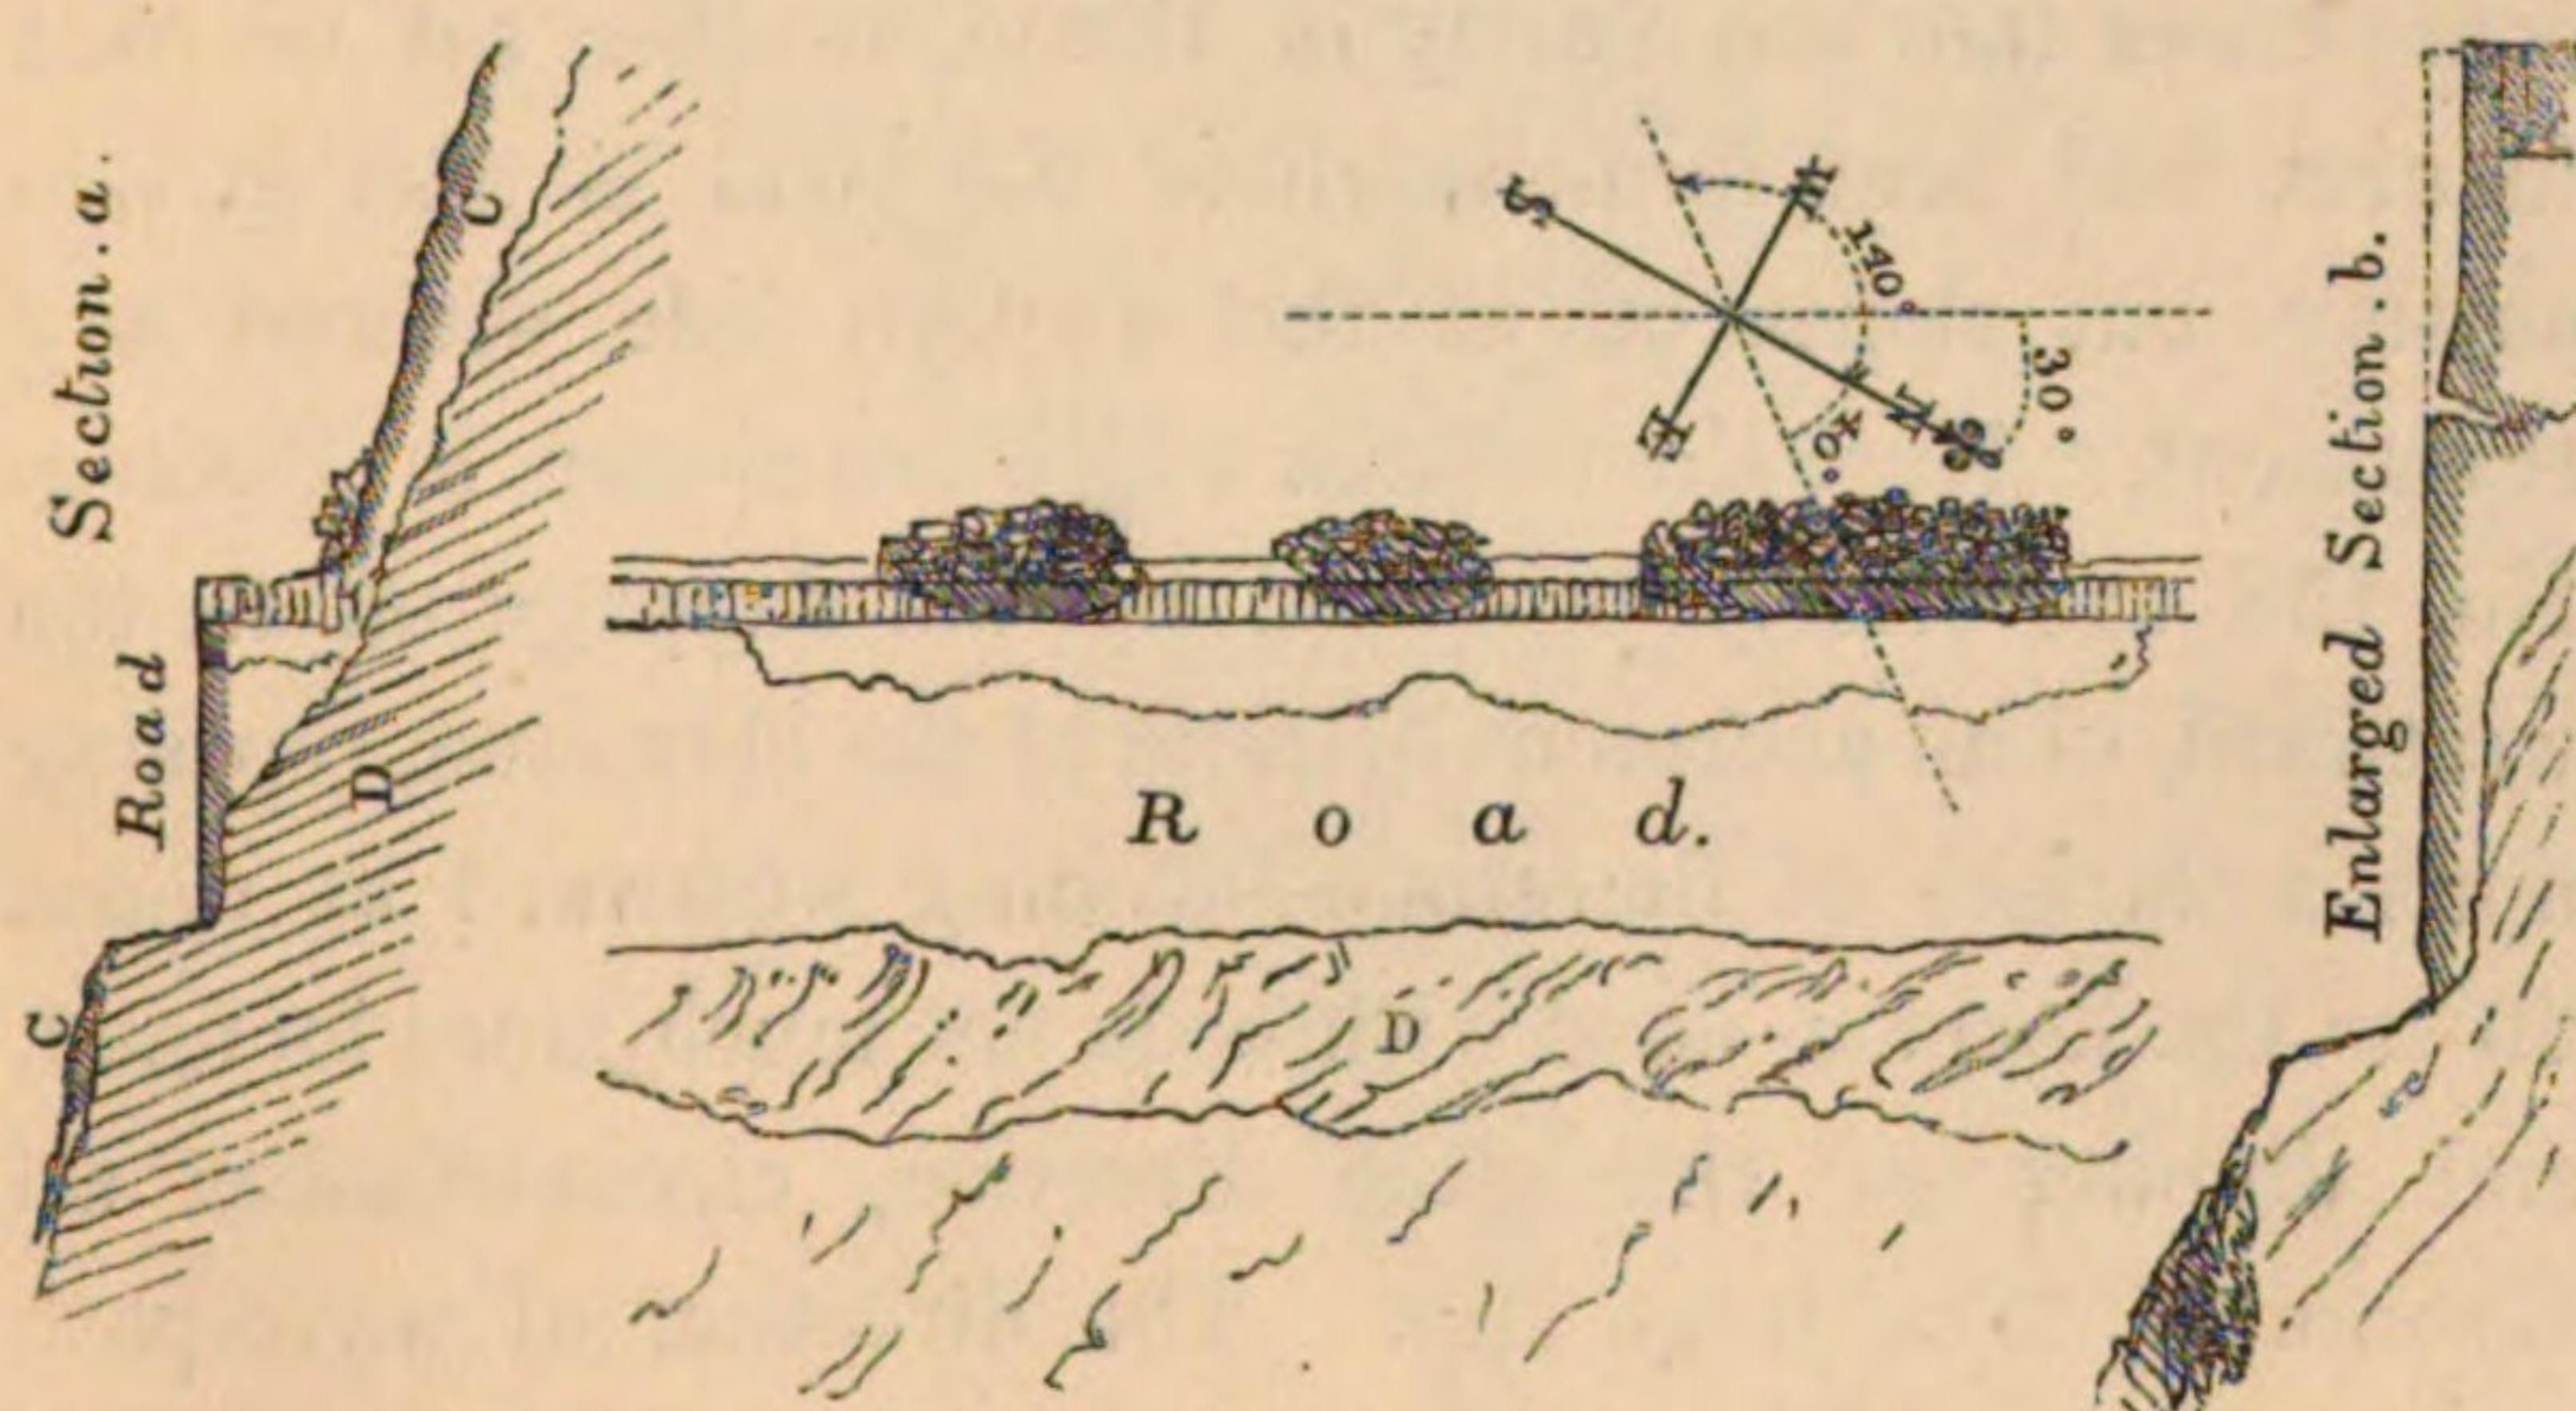
Fig. 157.

At the former point nearly, the road is formed upon a side cutting and small embankment, on limestone covered with 3 or 4 feet average, of arable clay land. It is sustained by an ill-built revetment wall of dry stone, with mortared top courses, in all about 12 feet high. The general direction of the centre line of the road is 30° W. of N., and nearly level. For a length of about 300 yards, an irregular longitudinal fissure was open, in the surface of the roadway, at about a quarter of its breadth from the revetment wall, of about 3 to 4 inches in width, and in some spots still, 10 or 12 inches deep, though much obliterated and filled by rain washings.

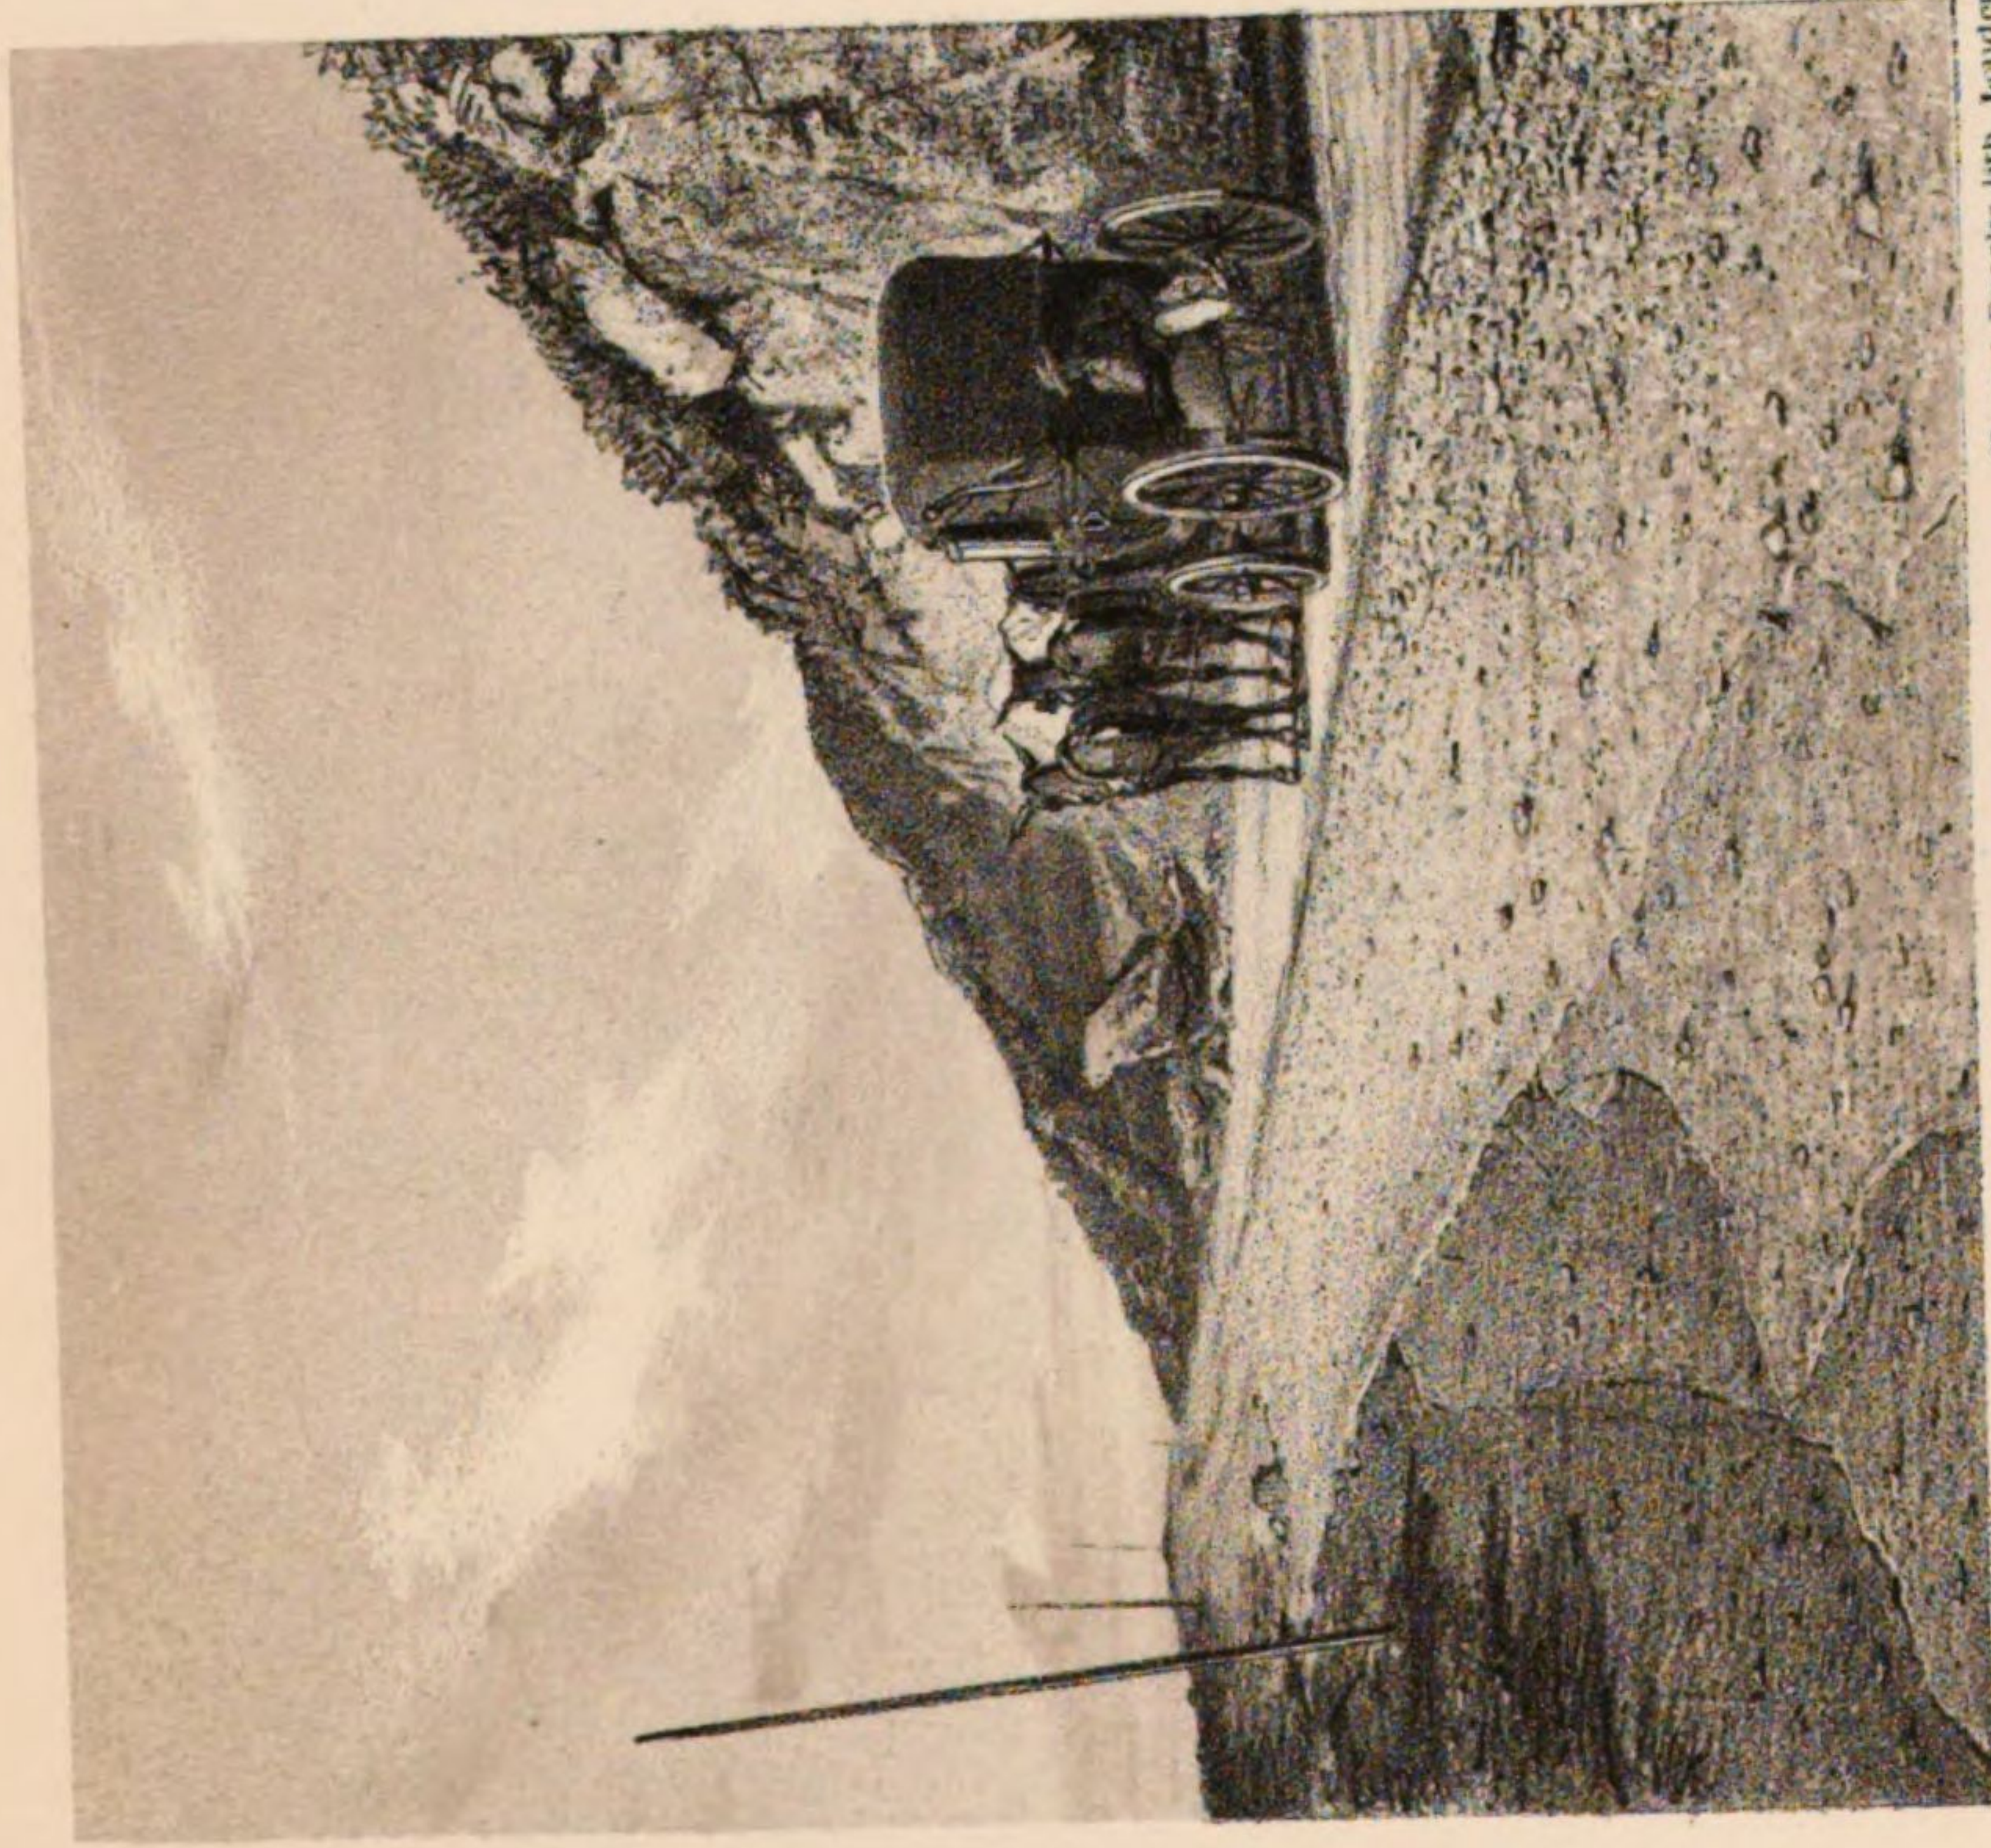
Photo Pl. 158.

About a mile further on, just before the rapid descent commences into the Valley of Diano, another set of road fissures had been formed, where the road is also in side cutting, but slopes off at the western side without any revetment. Here the fissures which are shown in Photog. No. 158 are clearly produced by the slippage off to the westward, of an enormous breadth of the clay land, reposing upon a surface of limestone—sloping westward at about 20° to the horizon—and with beds not much more inclined, and dipping in the same direction, circumstances all favourable to a large slip. The direction of wave-path shown, is about the same as the preceding. The telegraph poles all along this portion of the road, I remarked, had been loosened in the ground, and thrown out of plumb,

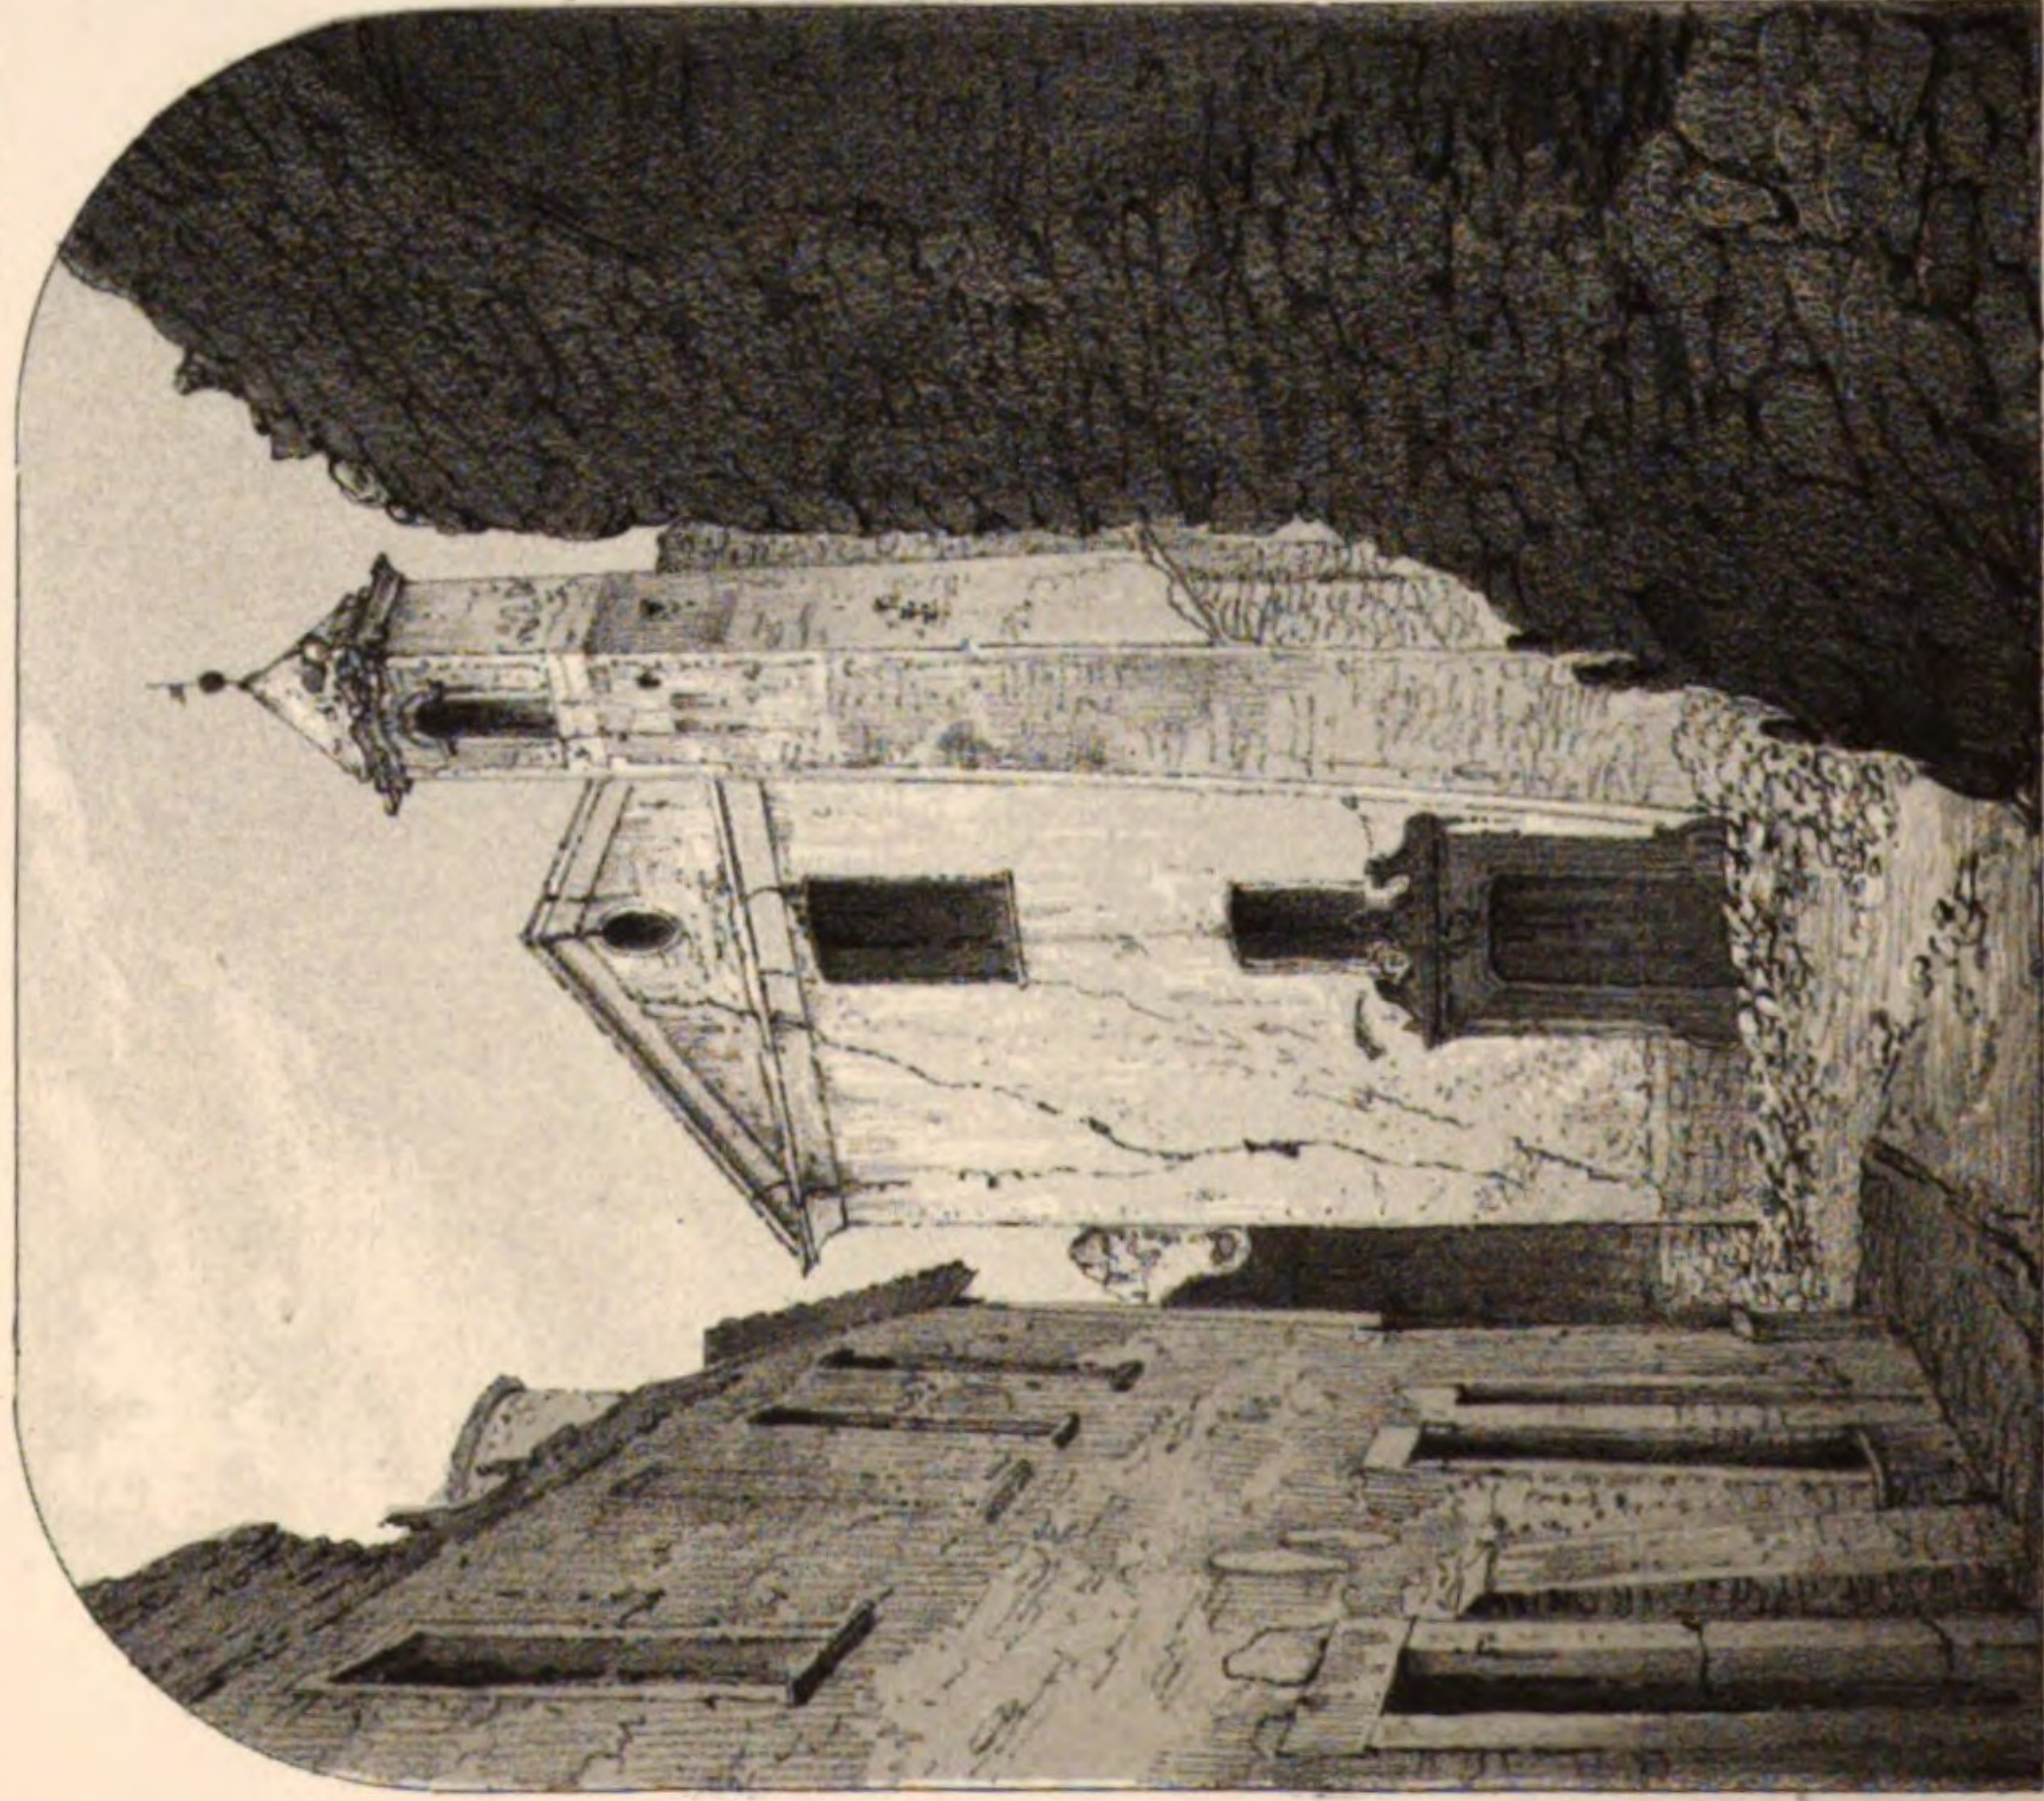
Photo. Pl. 167.

MONASTERY OF ST. CLAIRE, POLLA,
looking South West.

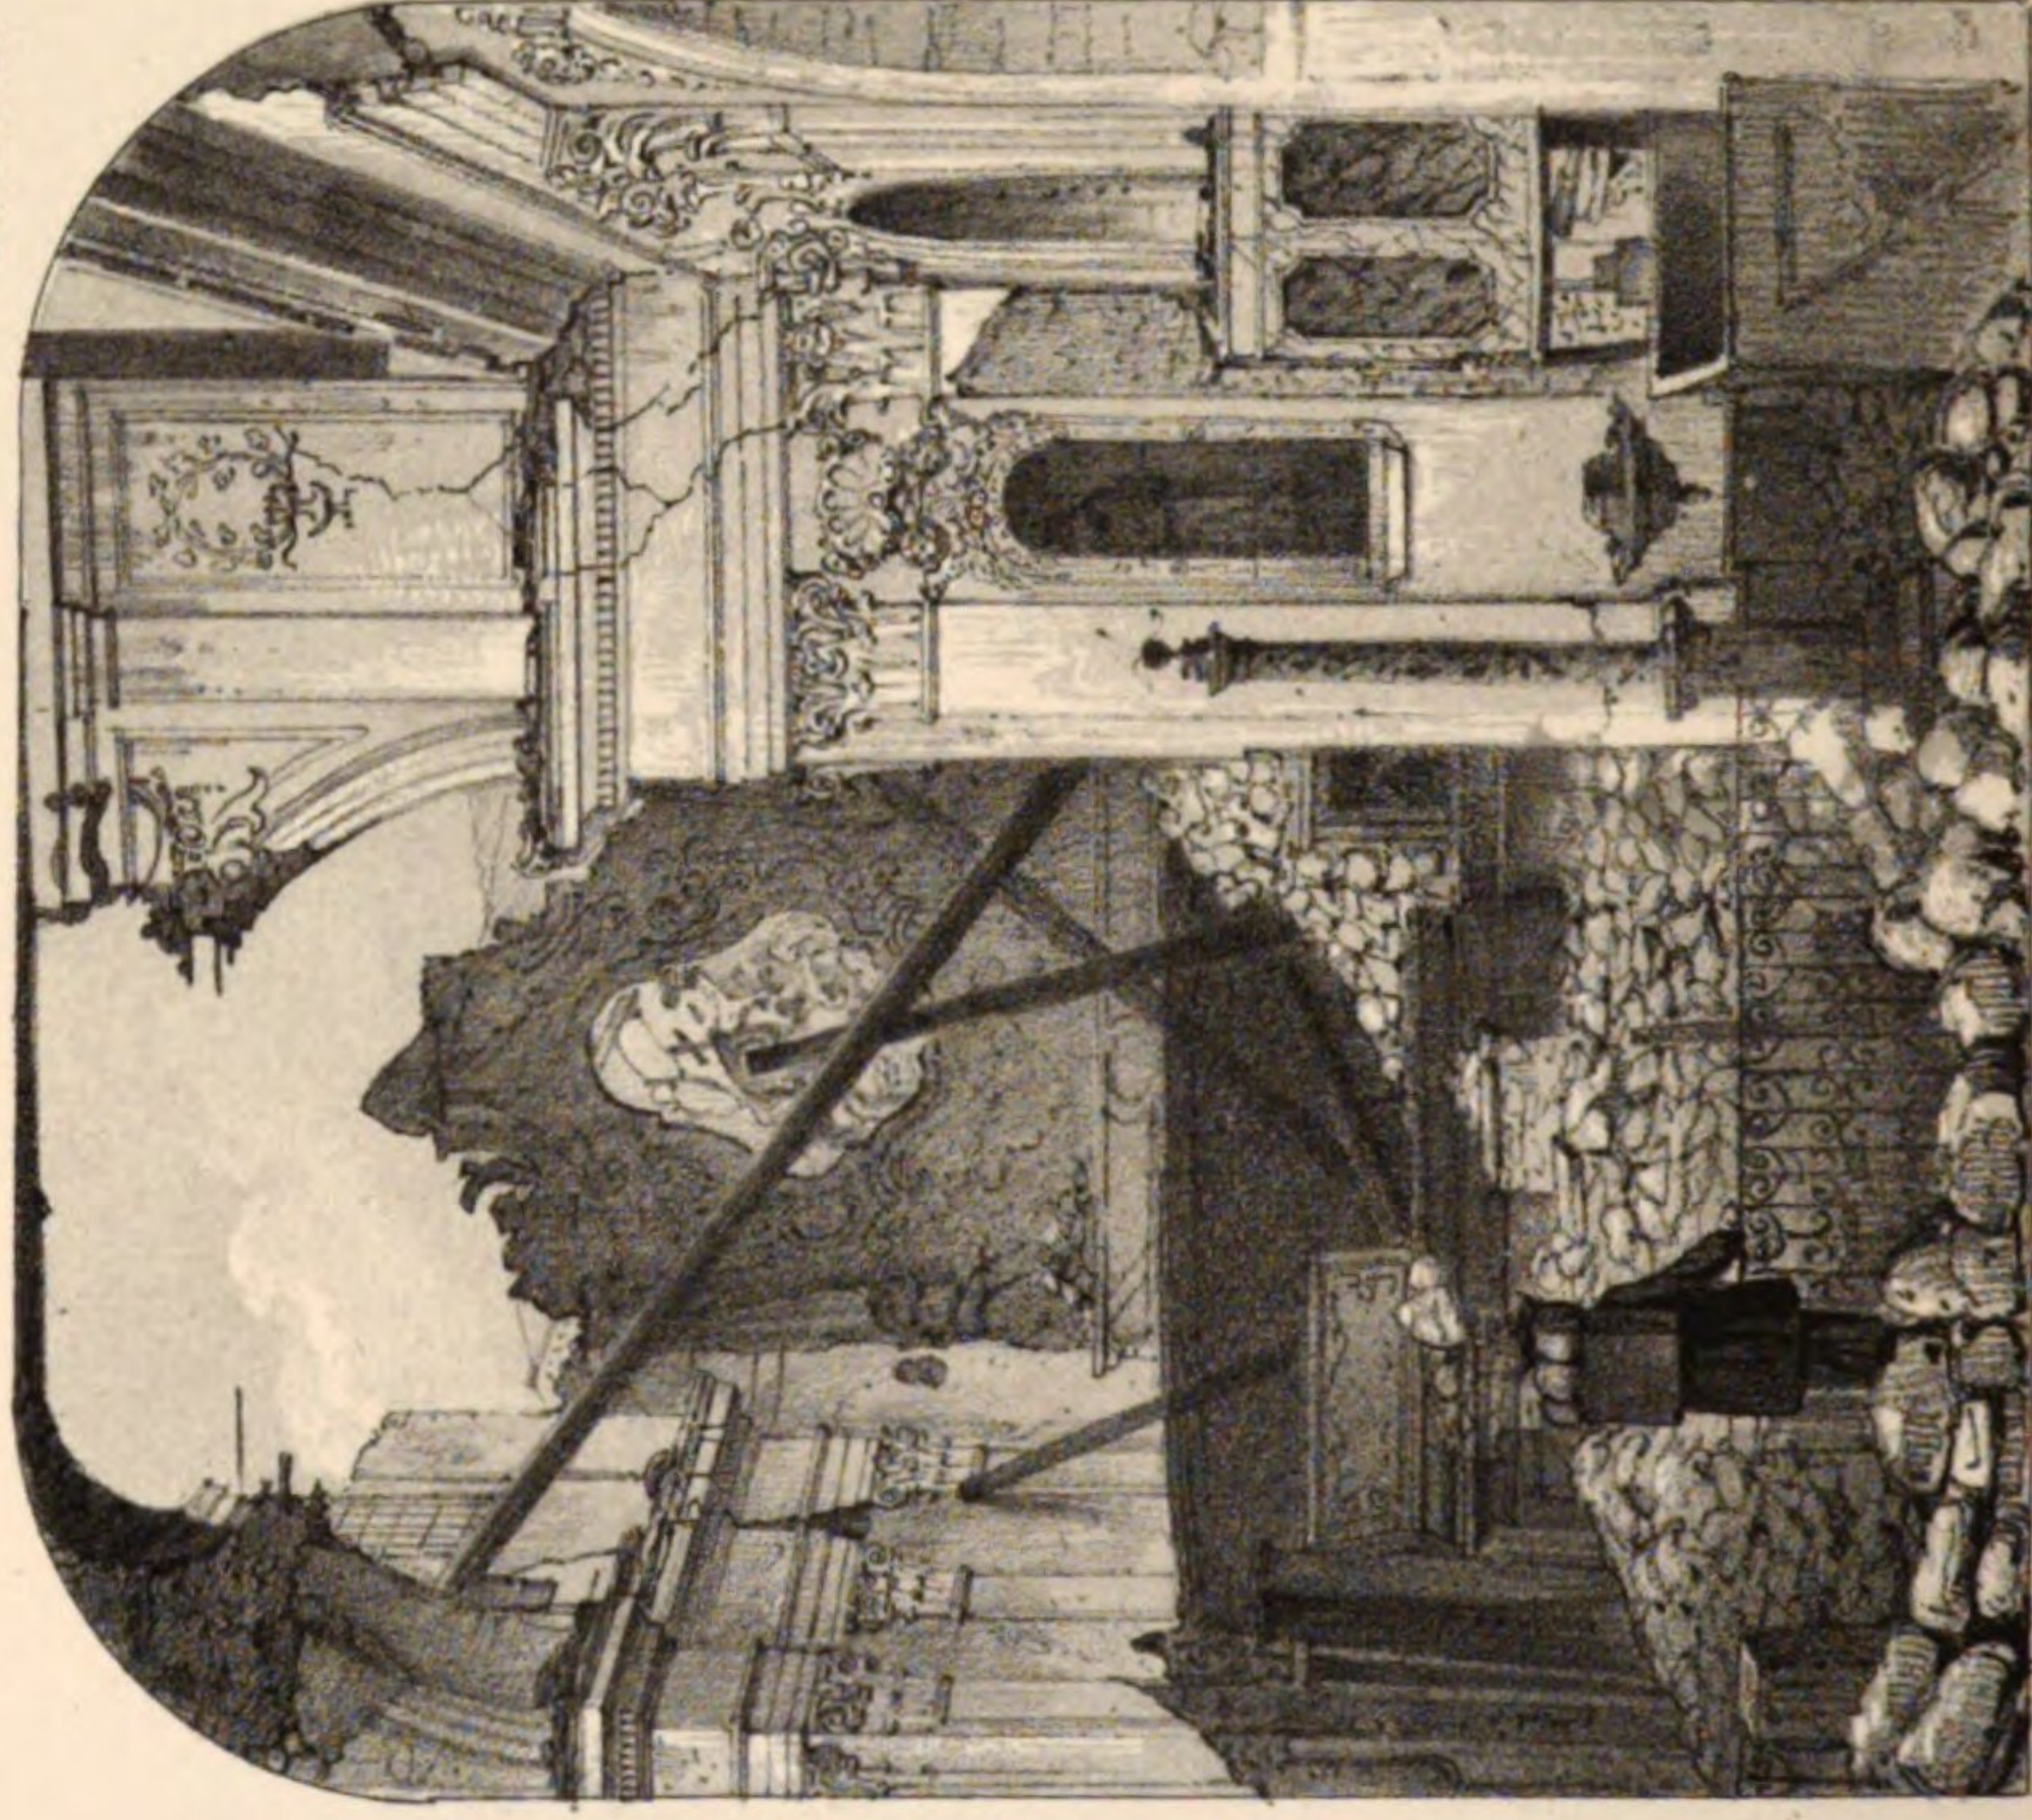
Photo. Pl. 168.

CHURCH OF THE MADONNA DI LORETTO, POLLA.

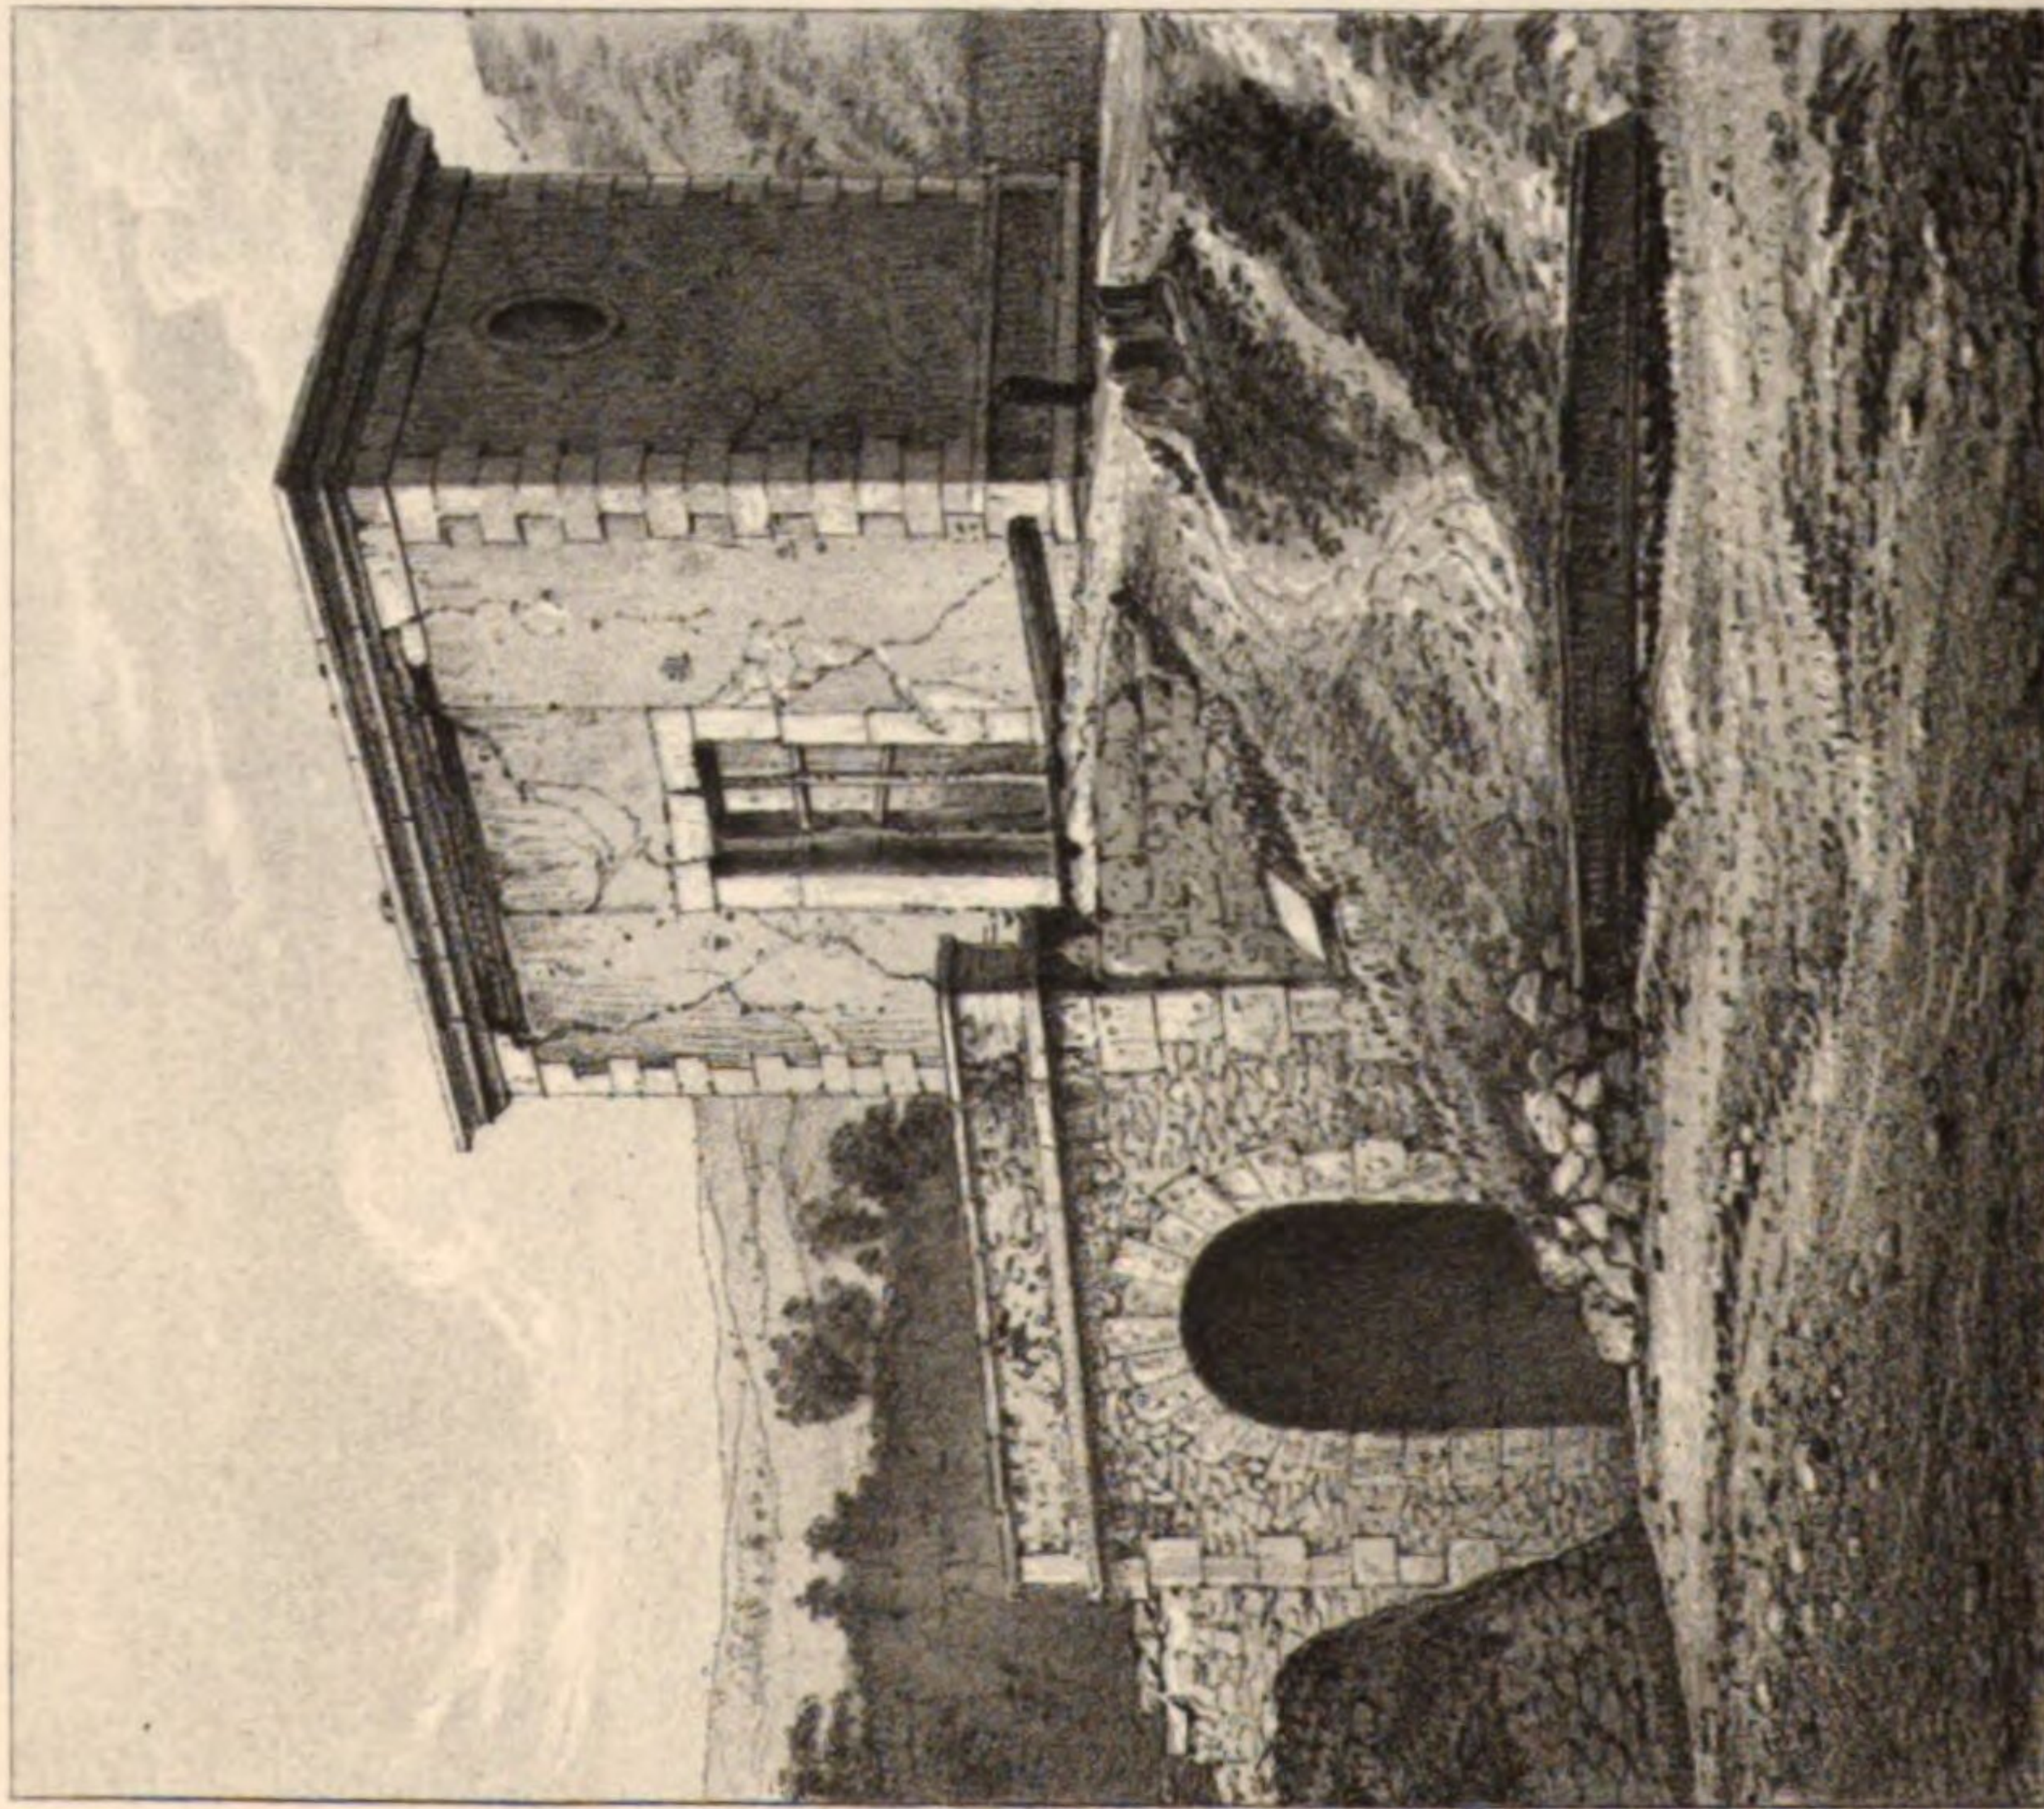
Photo. Pl. 174.

HOUSE ON THE BANK OF THE RIVER. POLLA,
looking Eastward.
